STANDARD GENERAL INSPECTION

DATE INSPECTION PERFORMED: January 3, 2024

INSPECTION ADDRESS: 123 Anywhere Rd. Reno, NV 89501

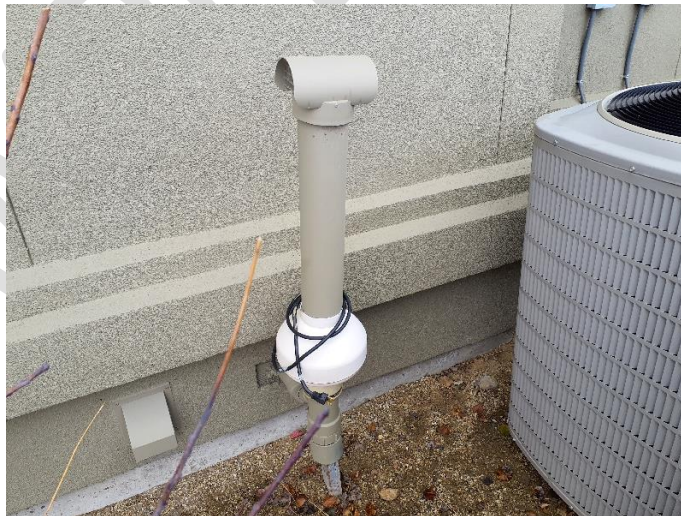
Photo 1

- A radon fan and system have been installed. The fan was plugged in and tested. It's unknown why fan was unplugged before inspection. Additional support is also needed below the fan. Recommend further evaluation of system. (p 1).

- A radon fan and system have been installed. The fan was plugged in and tested. It's unknown why fan was unplugged. Additional support is also needed below the fan. Recommend further evaluation of system. (p 1).

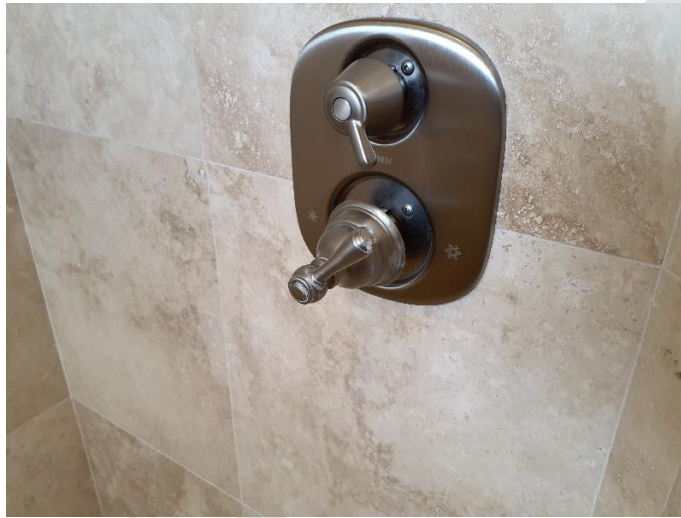
Photo 2

- **The hot and cold are reversed at the master bathroom shower valve. Recommend corrections. (p 2).**

- The hot and cold are reversed at the master bathroom shower valve. Recommend corrections. (p 2).

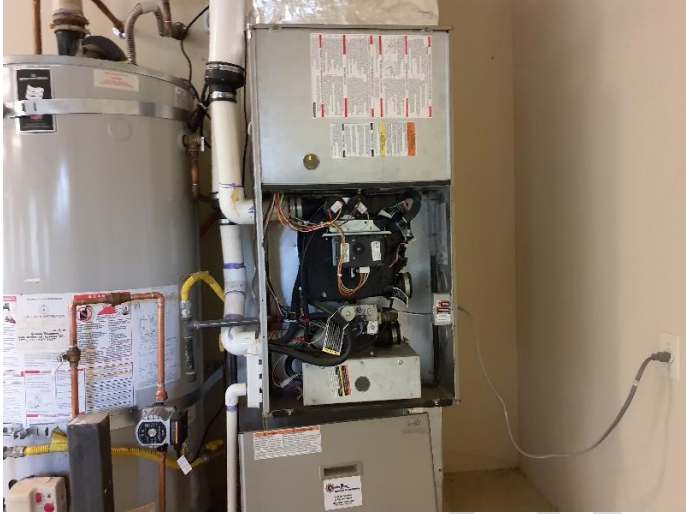
Photo 3

- The garage furnace manufactured by Bryant in 2006. The general life expectancy of a furnace is 20-25 years. (p 3).

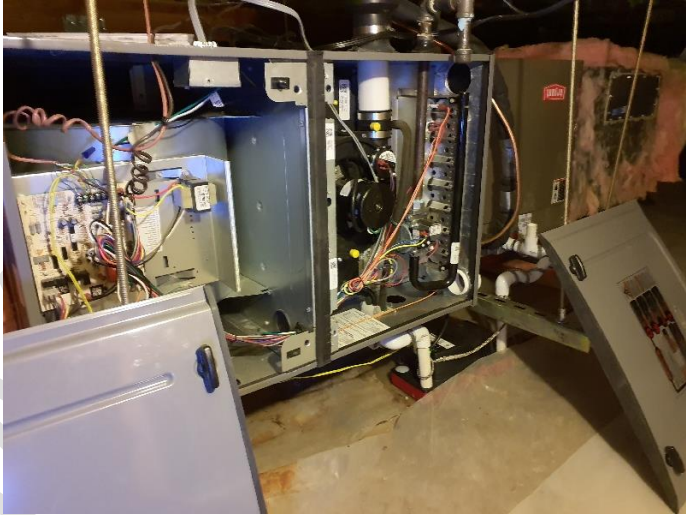
Photo 4

- The crawl space furnace is manufactured by Rheem in 2022. (p 4).

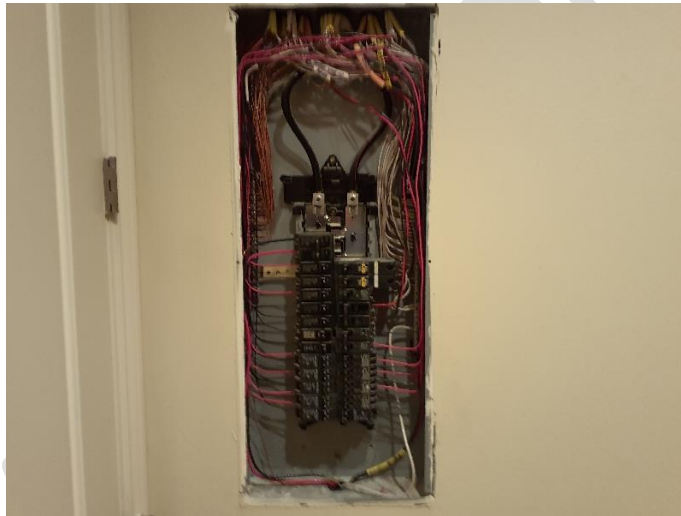
Photo 5

- The interior of the sub panel and main panel are adequate and breakers are labeled. (p 5).

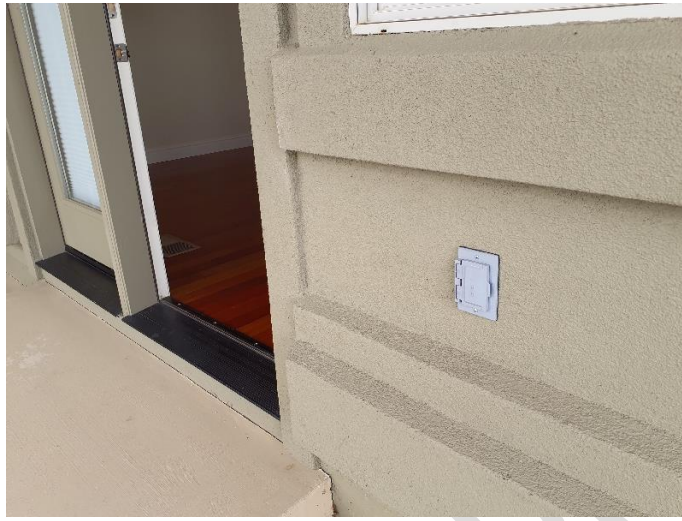
Photo 6

- The exterior GFCI outlet at the master bedroom patio door does not reset power. Further evaluation and repairs are needed. (p 6).

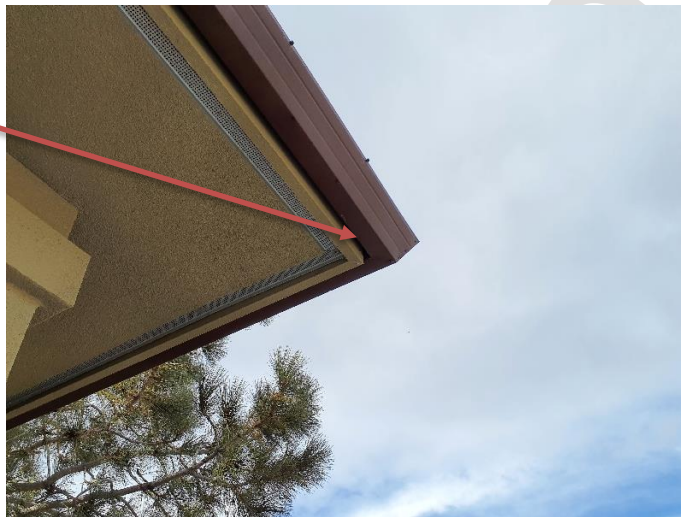
Photo 7

- The gutter corner on the northeast corner is leaking. Recommend repairs. (p 7).
